#### BURWASH, A TRIBUTARY OF KLUANE

#### Aurem Alliance Ltd., 2006-2017

Operation no. 205

## KLUANE PLACER AREA

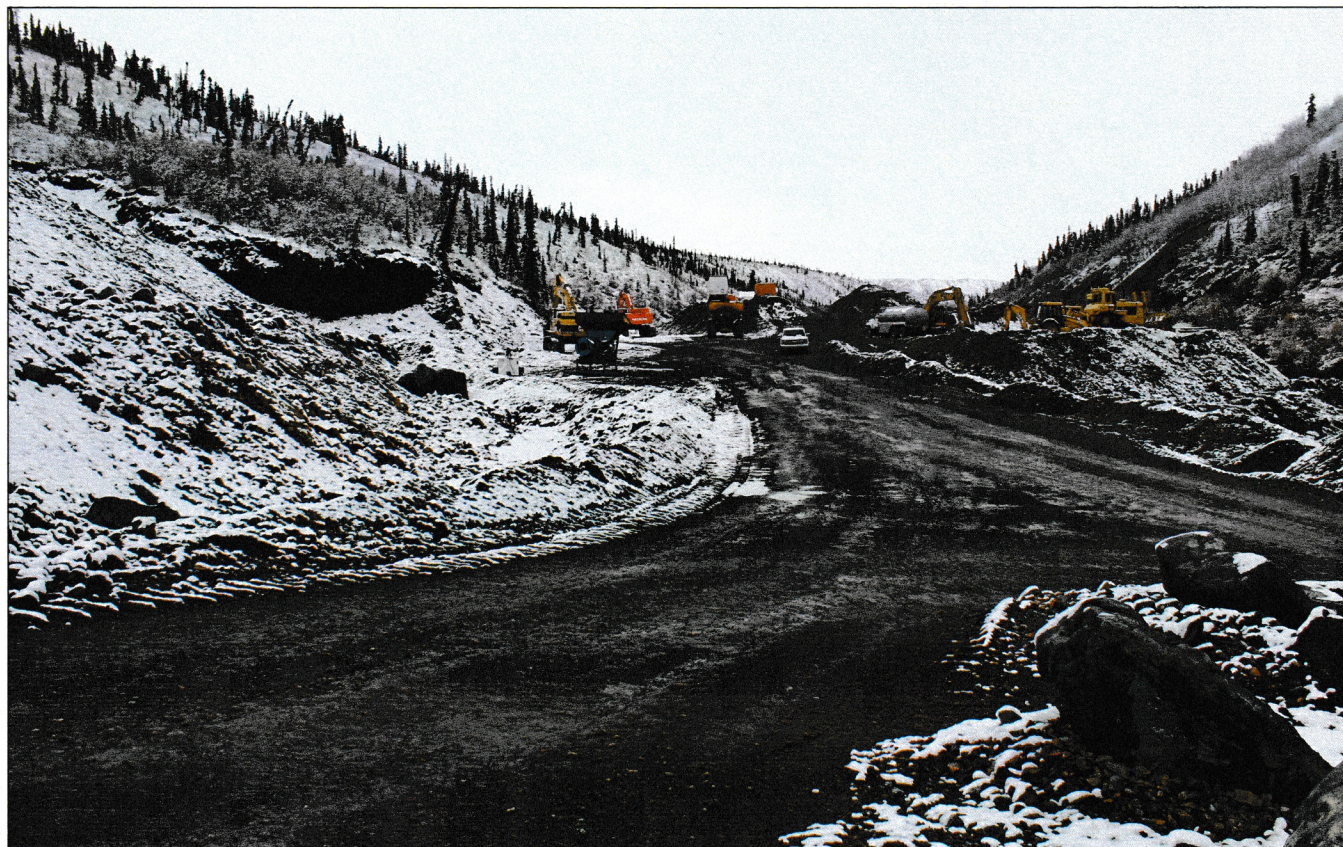
Equipment stationed on the right limit terrace that Aurem Alliance Ltd. mined through 2015 to 2017.

**SURFICIAL GEOLOGY AND STRATIGRAPHY** Aurem Alliance Ltd. mines a discontinuous right limit terrace, where the characteristics of the pay channel include coarse clasts on bedrock and a dark brown muddy gravel matrix. The right limit terrace comprises three units. Unit 1 is a coarse sandy matrix cobble-boulder gravel ranging from 1.5 to 3.0 m (4.9-9.8 ft) thick and overlies an undulating bedrock surface. Unit 2, 2.0 m (6.6 ft) thick, is interbedded medium to coarse sand and pebble-gravel,

with organic beds 5 to 10 cm thick. The uppermost unit, unit 3, is up to 4 m (13 ft) thick and consists of ice-rich muck with minor sand and woody debris. Sluiced material included 3.0 to 6.1 m (10-20 ft) of gravel and 0.6 to 0.9 m (2-3 ft) of bedrock, including all of unit 1 and most of unit 2 gravel.

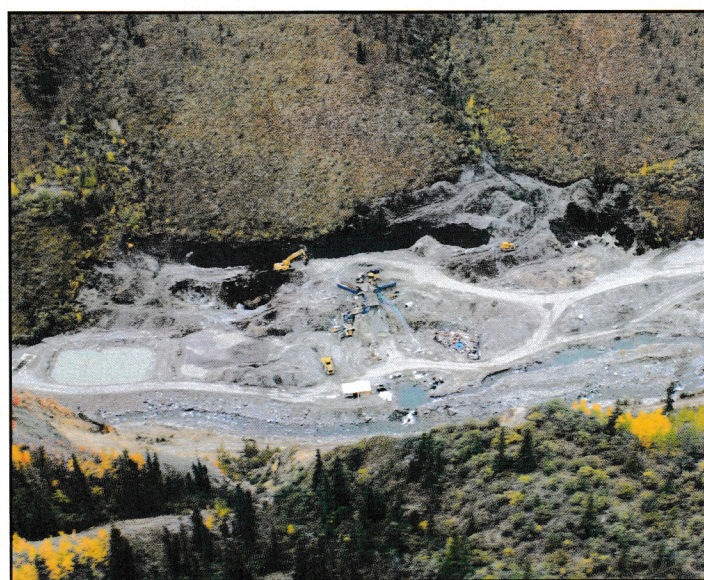
*Aurem Alliance's 2014 mining activity on the right limit of upper Burwash Creek.*

**SURFICIAL GEOLOGY AND STRATIGRAPHY** The 2014 right limit bench cut exposed three units. Unit 1, located at the base of the section, is pay gravel which varied in thickness from 1.5 to 3 m (4.9 to 9.8 ft) due to an undulating bedrock contact. The gravel is slightly imbricated towards the east (downstream) and consists of 25% boulders, 40% cobbles, and 35% pebbles, with a minimal matrix comprising coarse sand. Unit 2 consisted of 2.0 m (6.6 ft) of frozen interbedded medium to coarse sand and pebble-gravel, with organic beds 5 to 10 cm thick. Unit 3 caps the section and comprises up to 4 m (13 ft) of silty, ice-rich muck with approximately 25% visible ice in sheets and veins, and minor fine sand and woody debris. Sluiced material included 3.0 to 6.1 m (10 to 20 ft) of gravel and 0.6 to 0.9 m (2 to 3 ft) of bedrock.
